The largest cost drivers in a water AMI project

Athens Silaban, E Source
Elijah Lujan, E Source
Scott Jonas, Tacoma Water
Corey Bedient, Tacoma Water

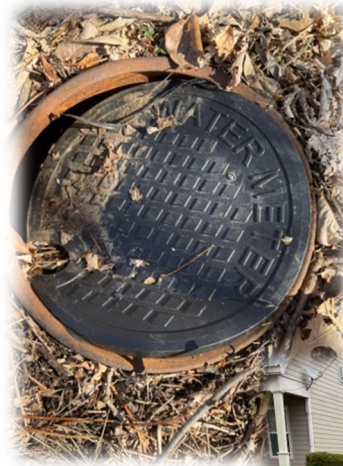
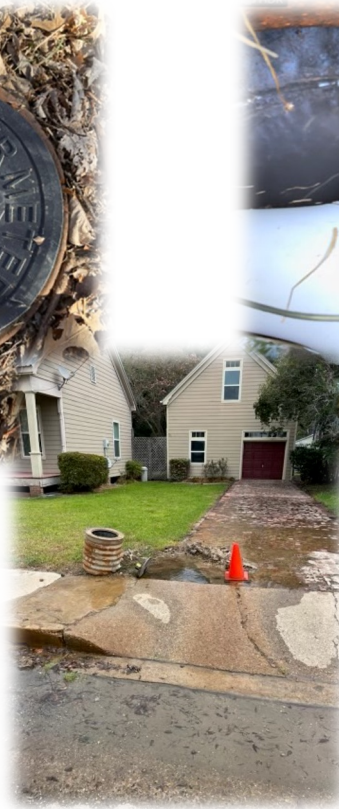
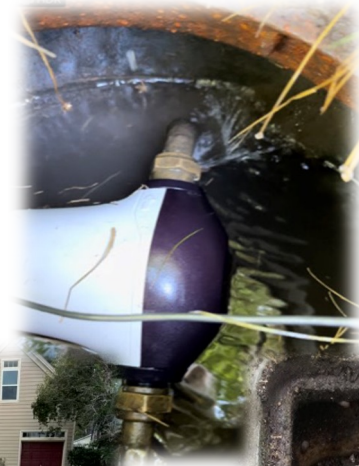
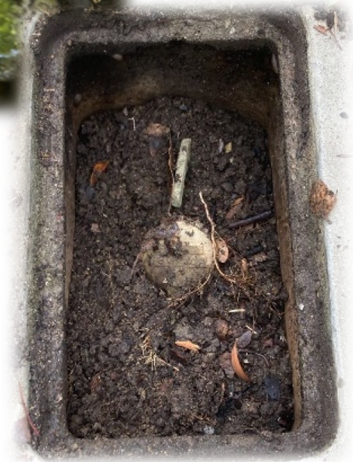
Common issues found at meter locations

- Utility database field errors
- Damaged components
- Meter buried or obstructed
- Equipment incompatibility
- Meter box obstruction of meter components
- Existing leaks

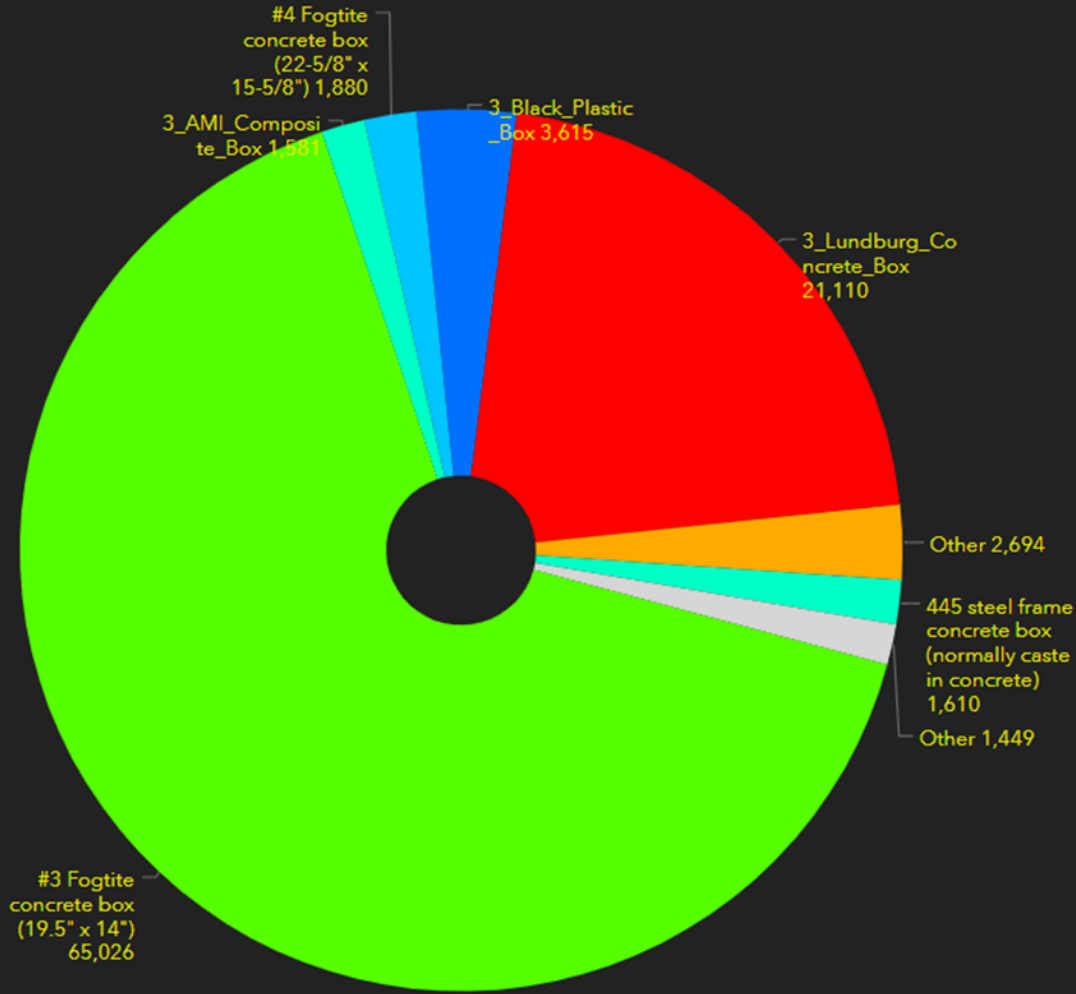
Information From Survey

- 102,000-Meters, Meter Boxes and lids inspected, Identified Material and Type
- Inspection took 5,288 hours to complete or 3.1 minutes per inspection
- 77,000-meter boxes had no issues. While 25,000 required further attention
 - Shallow, hard service
 - Shallow, soft service
 - Access issues
 - Meter Box conditions
- Of the 25,000 issues, 1,754 required Work Orders for corrective repairs.

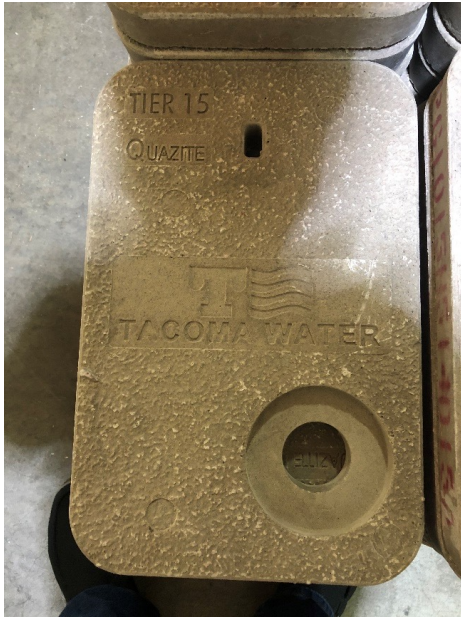
1. 10"x15" Lid

Three Types of New Quazite Meter Box Lids / 95% of Lid Replacements
